Retrofit Firesleeve — CPVC Sprinkler Edition

IN-SERVICE INSTALLATION - NO SHUTDOWN REQUIRED - OCCUPIED BUILDINGS - REMEDIAL WORKS

SRF RETROFIT FIRESLEEVE

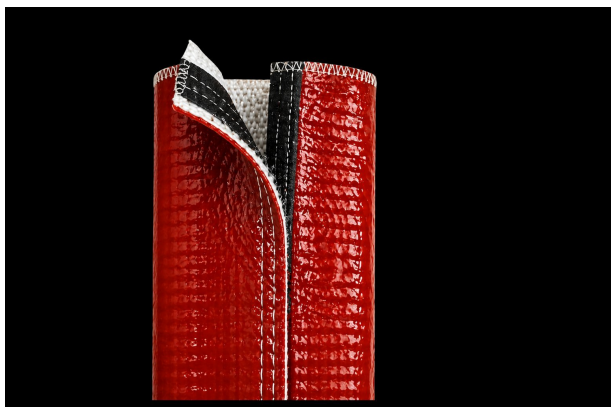
SRF Retrofit Firesleeve is manufactured from 'E' glass fibre coated with high-grade silicone elastomer rubber, with hook & loop closure.

Installs over existing CPVC sprinkler pipes in service without drain-down, disconnection or system shutdown. Chemically inert — no risk to CPVC pipe wall.

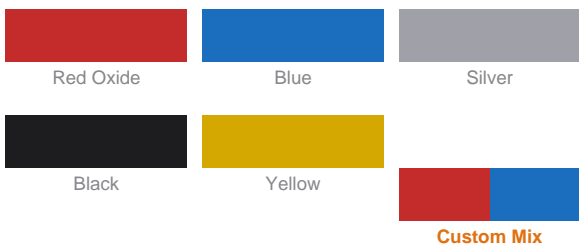
AVAILABLE COLOURS

Available in Red Oxide, Blue and Silver. Custom colours available on request.
