## Firesleeve — CPVC Sprinkler Edition

Chemically Inert Silicone Barrier · No Plasticizers · Made in Britain

# Firesleeve — CPVC Sprinkler Edition

Why a Barrier Layer is Essential

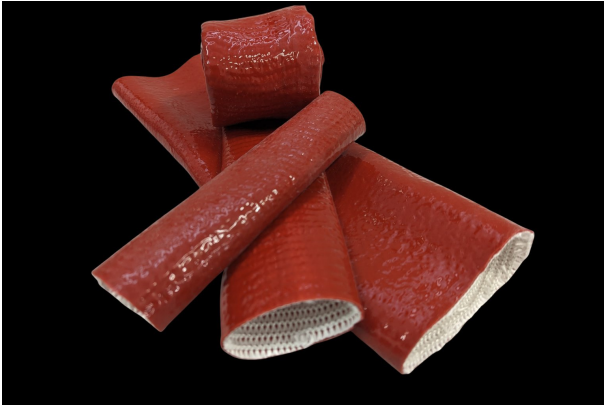
### SRF FIRESLEEVE

SRF Firesleeve is manufactured from 'E' glass fibre yarn knitted to form a sleeve and coated with high-grade silicone elastomer rubber.

Contains no plasticizers, esters or hydrocarbon compounds — creating a completely inert physical barrier between CPVC pipe and incompatible adjacent materials.

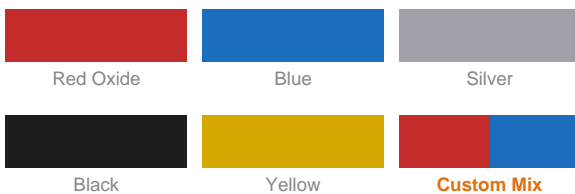
#### AVAILABLE COLOURS

Custom colours & cut lengths available on request.  
Glass locked edge option for ready-cut custom sizes.

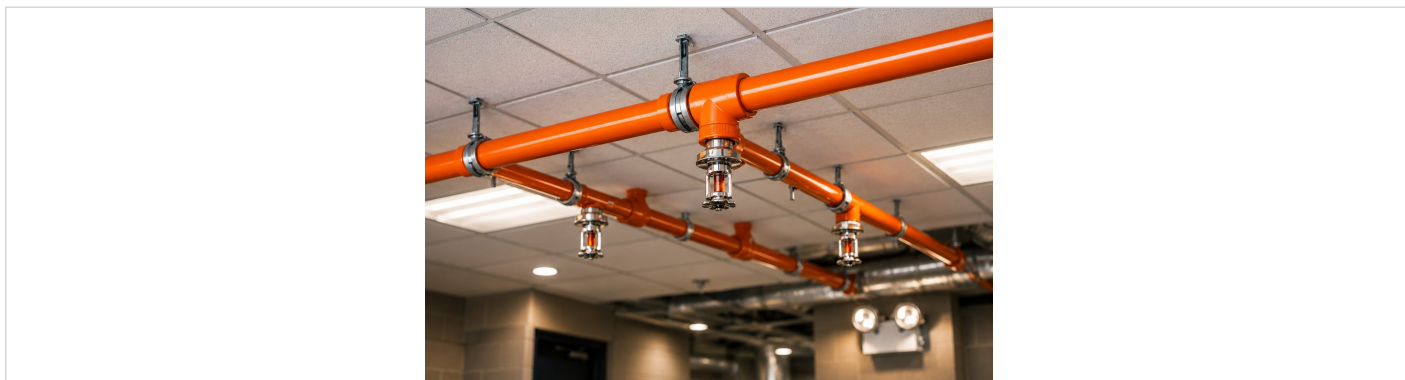
### CPVC FIRE SPRINKLER INSTALLATION

Orange CPVC fire sprinkler pipework — lightweight and fast to install, but vulnerable to chemical contamination from adjacent materials.

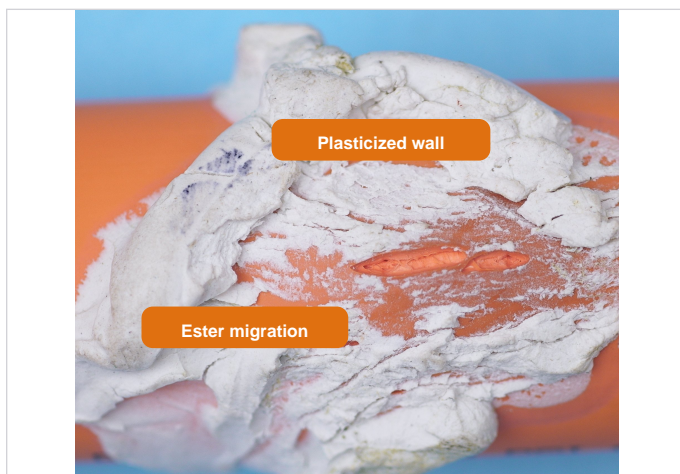
#### CASE 02 — PLASTICIZATION / ESTER MIGRATION

Forensic evidence — pipe wall softened and delaminated by ester compound migration.

Wrap S Riley Fabrications Firesleeve or Firesleeve Tape around the CPVC pipe at every penetration, joint and hanger point BEFORE any adjacent material is applied. Silicone rubber contains no plasticizers, esters or hydrocarbon compounds and will not migrate into the pipe wall — eliminating the contamination pathway. Tested by Spears Manufacturing for compatibility with FlameGuard CPVC fire sprinkler systems.
