# Firesleeve Tape — CPVC Sprinkler Edition

Penetration & Joint Isolation · Silicone Glass Tape · Made in Britain

## SRF FIRESLEEVE TAPE

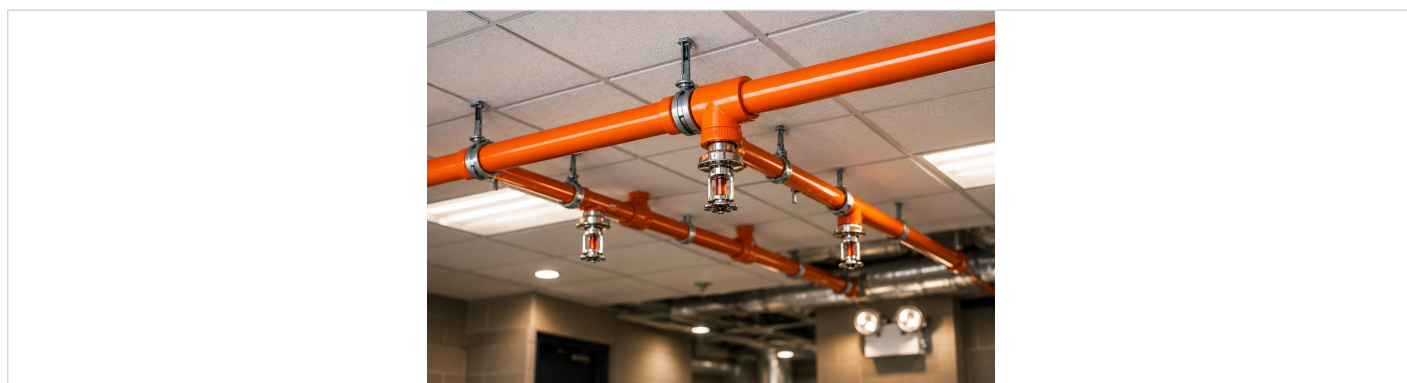
### CPVC FIRE SPRINKLER INSTALLATION

Orange CPVC fire sprinkler pipework — lightweight and fast to install, but vulnerable to chemical contamination from adjacent materials.

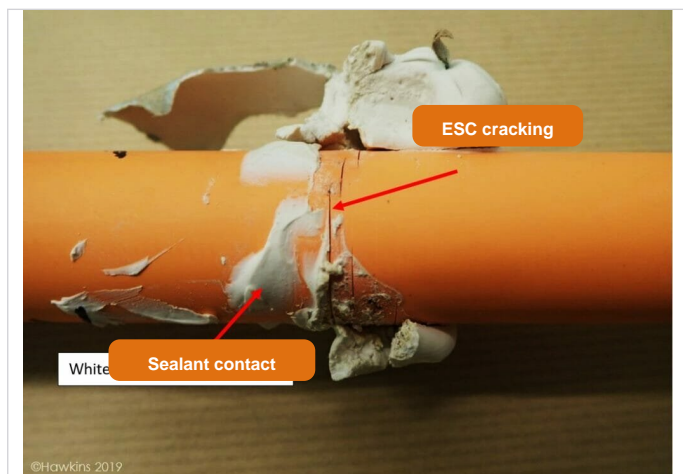
#### CASE 01 — ESC FROM FIRE-STOPPING SEALANT

Hawkins 2019 — CPVC cracking caused by incompatible fire-stopping compound.

Wrap S Riley Fabrications Firesleeve or Firesleeve Tape around the CPVC pipe at every penetration, joint and hanger point BEFORE any adjacent material is applied. Silicone rubber contains no plasticizers, esters or hydrocarbon compounds and will not migrate into the pipe wall — eliminating the contamination pathway. Tested by Spears Manufacturing for compatibility with FlameGuard CPVC fire sprinkler systems.

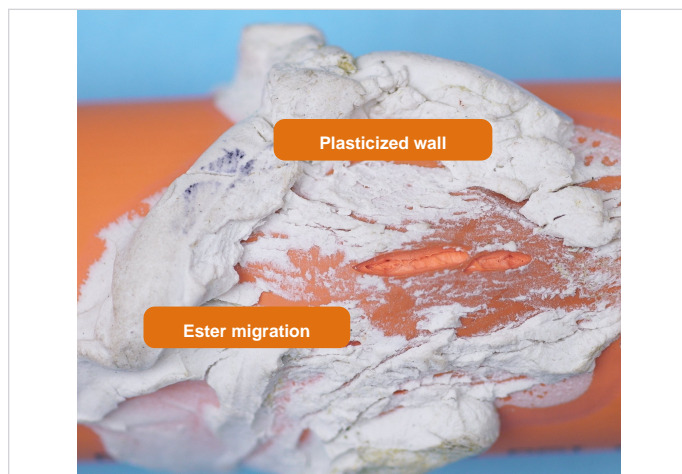
#### CASE 02 — PLASTICIZATION / ESTER MIGRATION

Forensic evidence — pipe wall softened and delaminated by ester compound migration.
